# DIGGIN' IT! LOCK ONE OF ONE

*Jon Jouppien finds it where he predicted.*

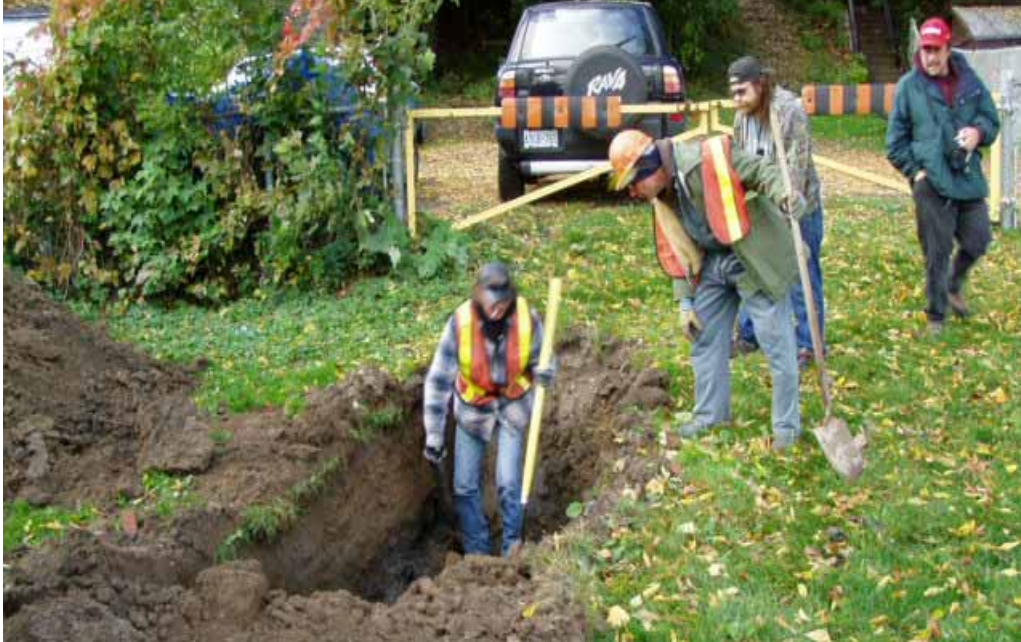
*Jon Jouppien and Crew at beginning of dig in Lakeside Park, Port Dalhousie*

At 9:00am, Jon began the dig and within minutes had uncovered the solid timbers of the Lock located in the west end of Lakeside Park just beneath the Dalhousie Street stairs. 46 feet to the east and before high noon had arrived, he'd found the east wall.

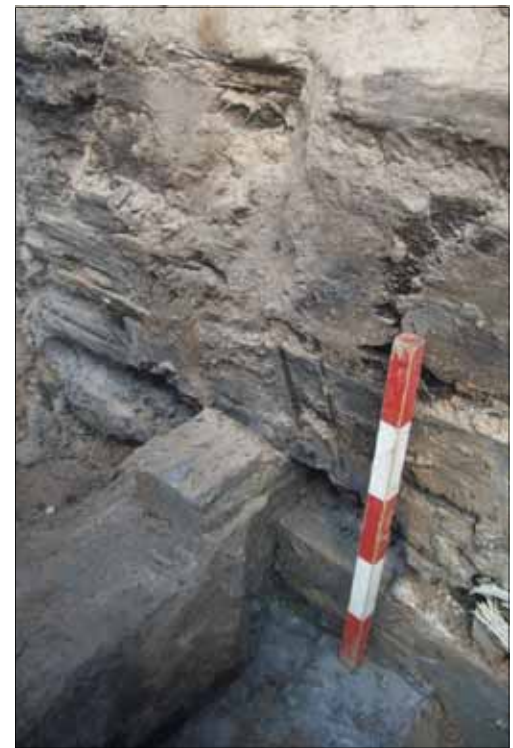
*One detail of the construction of the old lock—what appears to be a tenon joint.*

case. What was discovered was wood in pristine condition laid nearly two centuries before. 16 inch squared timbers were as solid as the day they were placed and their orientation defined the line of first channel of the First Welland Canal.

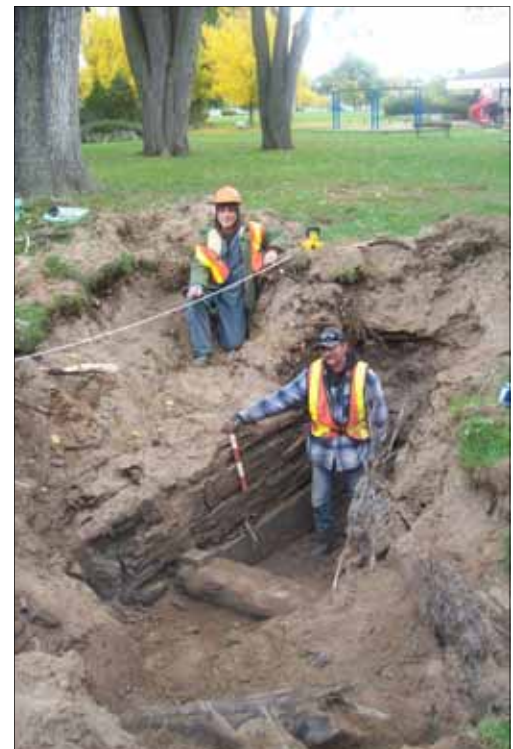
*Uncovering a bottom timber of the lock*
